**Flood Control Project Maintenance  
Levee Inspections**

**Fall 2018 Levee Maintenance Deficiency Summary Report**

**Reclamation District No. 0900 West Sacramento**

Waterway			Bank	Unit Miles
Unit No. 01 Sacramento River			Right	7.70
	Spring (March - May)	Summer (June - August)	(September - November) Fall	Winter (December - February)
Unit Maintenance Rating (Fall Only)			<b>A</b>	
Date of Inspection	3/13/2018 - 3/13/2018		10/18/2018 - 10/18/2018	
DWR Inspector	Dave Torres		Luz Dial	
Accompanied By	Chris Fogel RD 900		Tony Schwall RD 900

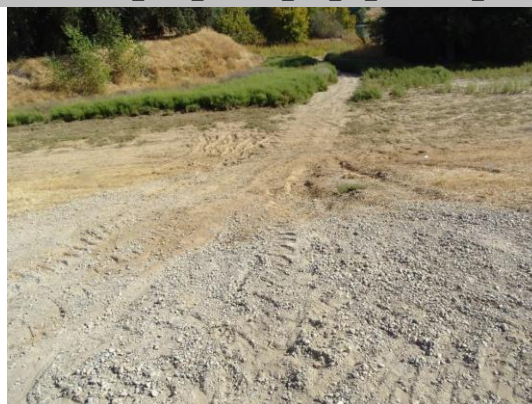
Photo 1 of 1 : FA\_2018\_RD0900\_230\_36\_20181022\_00021.jpg

LM Start	2.05	Rating **	A/W	Issue No.	36
LM End	2.05	Issue Type +	Ma	Location *	WS
Category	Earthen Levee			GPS Latitude/Longitude	
				Start	End
Item	Slope Stability			38.557865 °	38.557865 °
				-121.518175 °	-121.518175 °
DWR ID	DWR_RD0900_01_s_2018_36				
Comment Code					
S3 : Repair the levee slope damaged by vehicle traffic and prevent access where possible.					
Inspector Comment					
LMA repaired slope damage, but vehicles continue to access river.

View of slope damage from vehicular traffic. Fall 2018

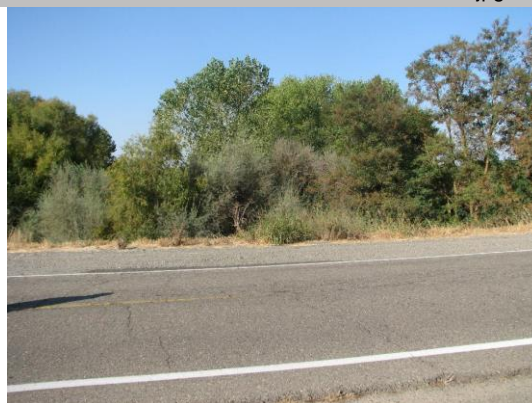
Photo 1 of 3 : UCIP\_FA\_2018\_37665\_68376.jpg

Comment Code					
Inspector Comment					
FS_ID:37665					
DS_ID:17772					
EP_NO: N/A					
Repair Type: Non-Urgent					
Crossing Status: Found					
UCIP Comments: Dense vegetation limits the inspector's visibility to identify signs of pipe failure (leaks) along the slope. Recommend removing vegetation along pipe alignment to conduct proper inspection of structure and appurtenances.					
FIELD_STRUCT_DESC: 42-inch drainage pipe of unknown material through the levee, 21.5 feet below the levee crown. Slide gate in concrete riser on the waterside (WS) slope. Flap gate on the WS end.					
[Additional Reference(s): DWR Levee Log, 2003]					
FS Date: 10/6/2009

View of levee crown at crossing.

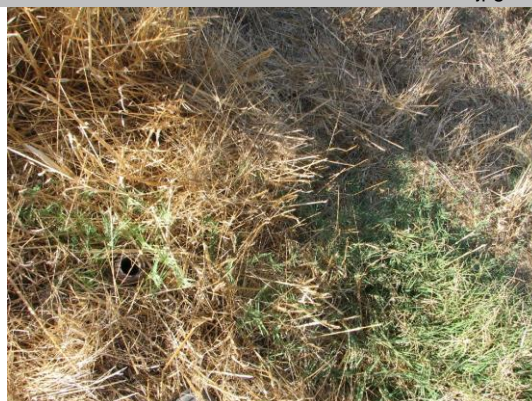
Photo 2 of 3 : UCIP\_FA\_2018\_37665\_68375.jpg

LM Start	2.15	Rating **	M	Issue No.	356 (cont)	
LM End	2.15	Issue Type +	En	Location *		
Category	Supplemental			GPS Latitude/Longitude		
				Start	End	
Item	DWR UCIP Field Study			38.556994 °	38.556994 °	
				-121.516843 °	-121.516843 °	
DWR ID	17772					
Comment Code						
Inspector Comment						
FS_ID:37665 DS_ID:17772 EP_NO: N/A Repair Type: Non-Urgent Crossing Status: Found UCIP Comments: Dense vegetation limits the inspector's visibility to identify signs of pipe failure (leaks) along the slope. Recommend removing vegetation along pipe alignment to conduct proper inspection of structure and appurtenances. FIELD_STRUCT_DESC: 42-inch drainage pipe of unknown material through the levee, 21.5 feet below the levee crown. Slide gate in concrete riser on the waterside (WS) slope. Flap gate on the WS end. [Additional Reference(s): DWR Levee Log, 2003] FS Date: 10/6/2009

Air vent visible through dense vegetation.

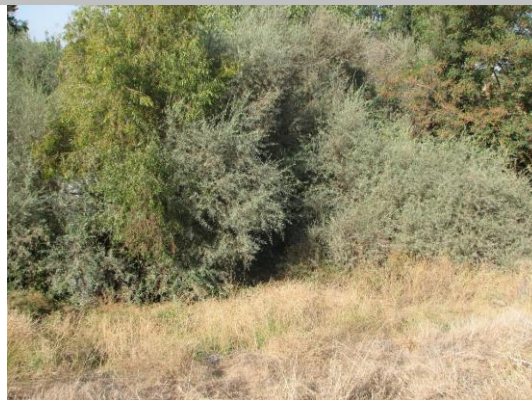
Photo 3 of 3 : UCIP\_FA\_2018\_37665\_68374.jpg

Dense vegetation along landward side.

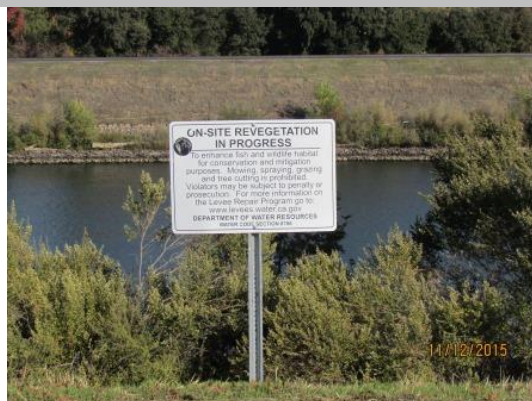
Photo 1 of 1 : FA\_2018\_RD0900\_230\_17\_20180910\_00005.jpg

View of the DWR environmental mitigation site.

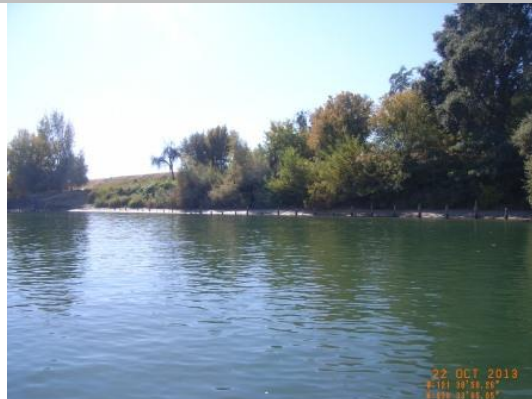
Photo 1 of 1 : FA\_2018\_RD0900\_230\_29\_20181023\_00023.jpg

2017 Site ID: SAC 56.5 R  
Status: Eroding  
2017 Field Notes: Fresh toe erosion.  
Site History: 1997 - Low berm is contributing to erosion. Old timber pile dikes above water parallel to bank. The upstream mitigation low berm causes a flow separation at the site. 1999 - Some new localized erosion with less than one foot of bank retreat. 2000 - Some new erosion at the upstream end. Fat toe deposits at toe. 2003 - Some new erosion upstream, but have a wide berm. 2011 - Minor new erosion at toe.

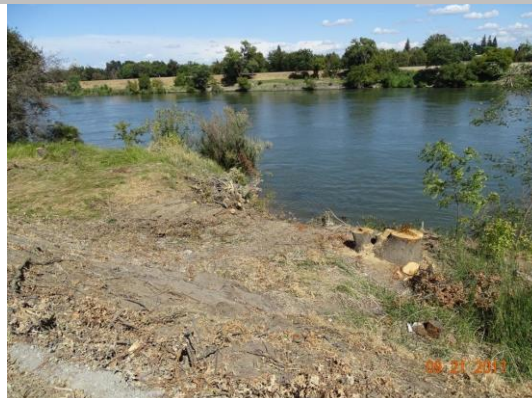
Photo 1 of 2 : FA\_2018\_RD0900\_230\_57\_20180910\_00009.jpg

LM Start	2.57	Rating **	A/W	Issue No.	57
LM End	2.57	Issue Type +	Ob	Location *	WS
Category	Earthen Levee			GPS Latitude/Longitude	
				Start	End
Item	Erosion / Bank Caving			38.550965 °	38.550965 °
				-121.514795 °	-121.514795 °
DWR ID	DWR RD0900 01 f 2017 57

View of the existing erosion site on the waterside berm of the levee. Fall 2017

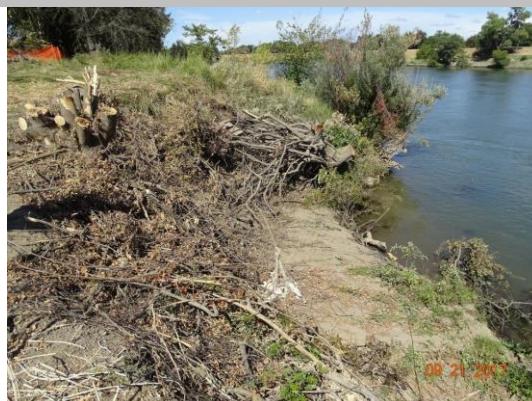
Photo 2 of 2 : FA\_2018\_RD0900\_230\_57\_20180910\_00010.jpg

The contractor is planning on placing riprap in this area. This picture was taken from the waterside berm of the levee looking upstream. Fall 2017

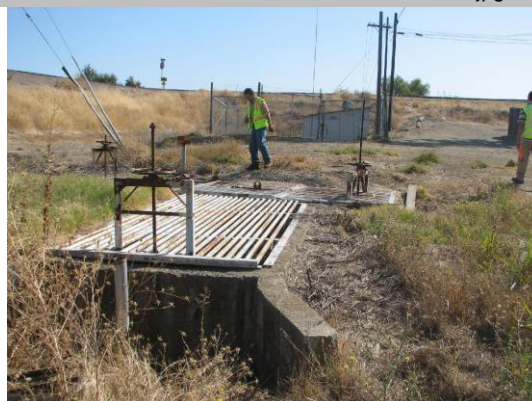
Photo 1 of 3 : UCIP\_FA\_2018\_37668\_68391.jpg

View of concrete structure located on landward side.

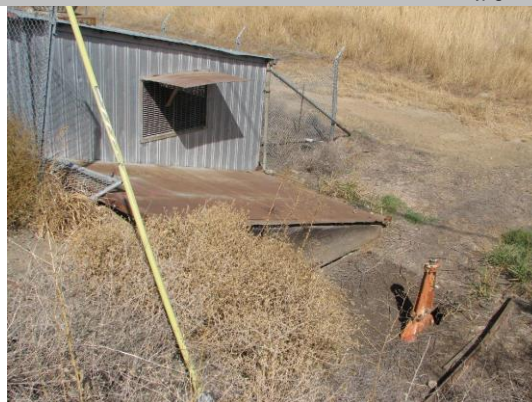
Photo 2 of 3 : UCIP\_FA\_2018\_37668\_68390.jpg

Pump house located on landward side.

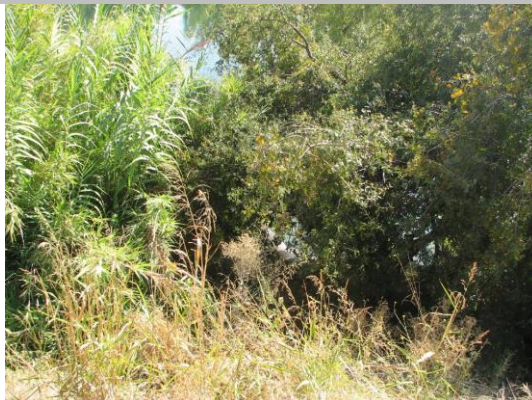
Photo 3 of 3 : UCIP\_FA\_2018\_37668\_68389.jpg

FS\_ID:37668  
DS\_ID:17769  
EP\_NO: N/A  
Repair Type: Non-Urgent  
Crossing Status: Found  
UCIP Comments: 02/26/2018 Pipe is located within the construction limits of the Levee Improvement Project for RD0900, As-builts PENDING Project Completion. -- UNDER CONSTRUCTION Levee Improvement Project, construction schedule Summer 2016 to November 2018. Levee improvements address through seepage, underseepage and slope stability and include strengthen-in-place improvements and construction of a setback levee. Reference: [Issued FOR CONSTRUCTION] West Sacramento Area Flood Control Agency Southport Levee Improvement Project Early Implementation Program. Southport Sacramento River Levee: (Stat 3+90 to Station 287+57). Volume 3 (W.O. # 41164) December 2016 Conformed Submittal. HDR Engineering Inc. Folsom, CA – (DWR UCIP – O. Magana) 10/06/2009 Dense vegetation limits the inspector's visibility to identify signs of pipe failure (leaks) along the slope. Recommend removing vegetation along pipe alignment to conduct proper inspection of structure and appurtenances. (DWR UCIP - O. Magana) FIELD\_STRUCT\_DESC: 24-inch pipe through the levee, 22.0 feet below the crown. Pump house at the landside (LS) toe. Screw gate in LS of the levee. Additional Reference(s): USACE Sacramento O&M Manual Unit No. 116, August 1955, revised 2011, (USGS River Mile [RM] 55.65), As-built drawing# 6-13-1100 page 3, January 1933] FS Date: 10/6/2009

Pipe visible on waterward side visible through dense vegetation.

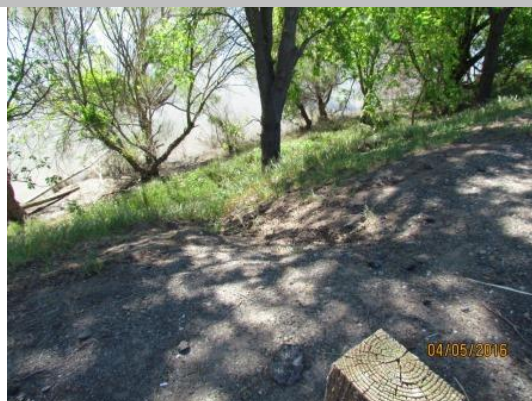
Photo 1 of 2 : FA\_2018\_RD0900\_230\_4\_20180910\_00001.jpg

Updated picture of the slope instability on the waterside of the levee looking downstream during spring 2016 inspection.

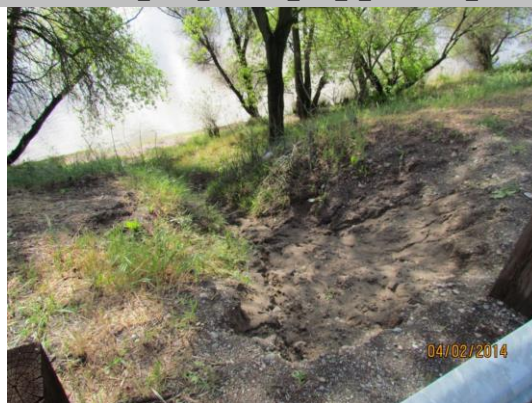
Photo 2 of 2 : FA\_2018\_RD0900\_230\_4\_20180910\_00002.jpg

A slope instability was found on the waterside slope of the levee looking downstream.

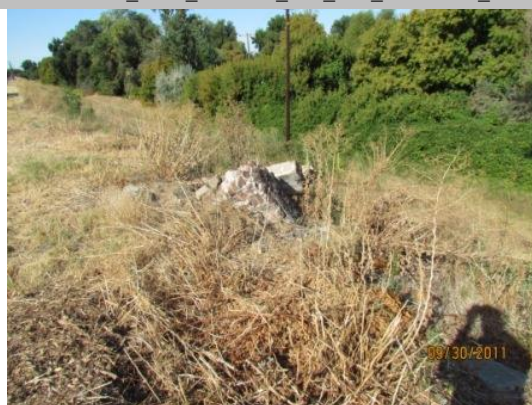
Photo 1 of 1 : FA\_2018\_RD0900\_230\_327\_20180910\_00012.jpg

Concrete debris were found on the landside of the levee looking upstream.

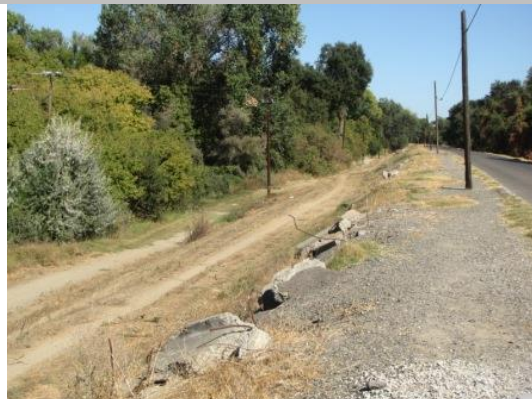
Photo 1 of 1 : FA\_2018\_RD0900\_230\_54\_20180910\_00008.jpg

View of concrete debris with metal looking upstream.

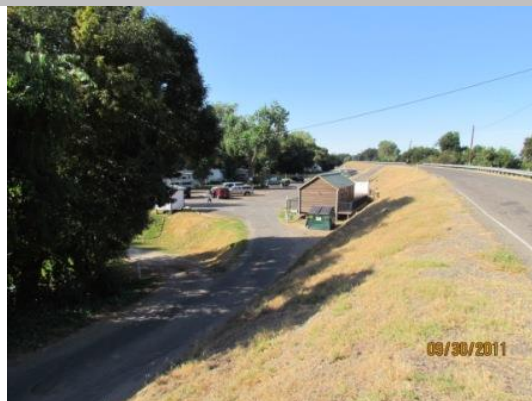
Photo 1 of 1 : FA\_2018\_RD0900\_230\_20\_20180910\_00006.jpg

View of Sherwood harbor's unpermitted properties on the waterside of the levee. The picture was taken from the crown looking upstream.

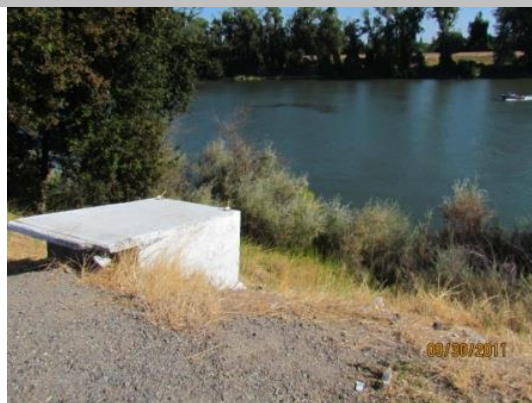
Photo 1 of 1 : FA\_2018\_RD0900\_230\_330\_20180910\_00013.jpg

Concrete anchor was found on the waterside slope of the levee looking upstream.

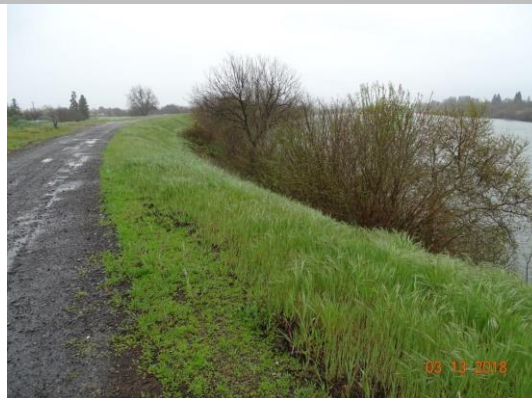
Photo 1 of 1 : FA\_2018\_RD0900\_230\_24\_20180910\_00007.jpg

Vegetation waterside looking north.

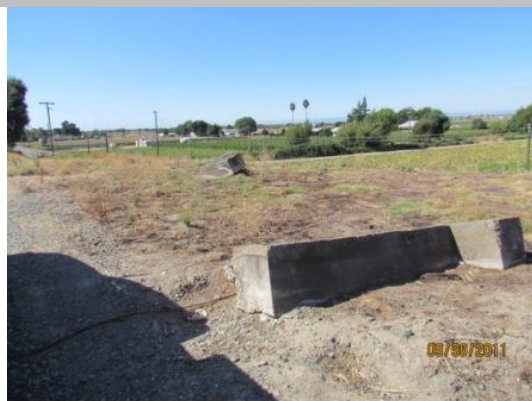
Photo 1 of 1 : FA\_2018\_RD0900\_230\_343\_20180910\_00014.jpg

Concrete debris from old rail road track was found on the landside of the levee looking upstream.

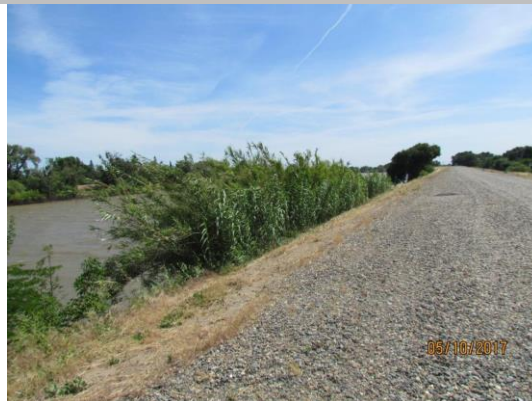
Photo 1 of 1 : FA\_2018\_RD0900\_230\_59\_20180910\_00011.jpg

View of the arundo on the waterside of the levee during spring 2017 inspection.

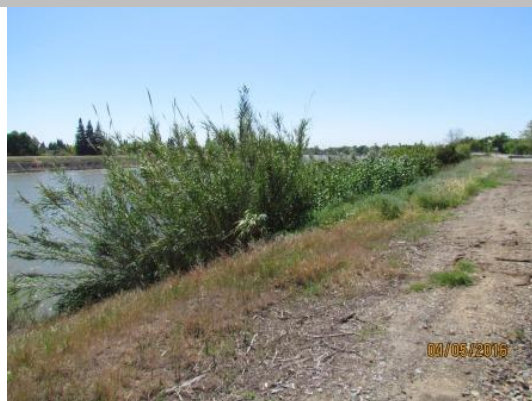
Photo 1 of 2 : FA\_2018\_RD0900\_230\_15\_20180910\_00003.jpg

Updated picture of the arundo on the waterside of the levee during spring 2016 inspection.

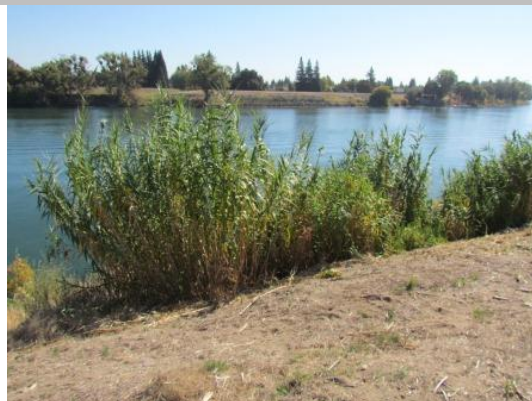
Photo 2 of 2 : FA\_2018\_RD0900\_230\_15\_20180910\_00004.jpg

View of arundo on the waterside of the levee looking downstream.

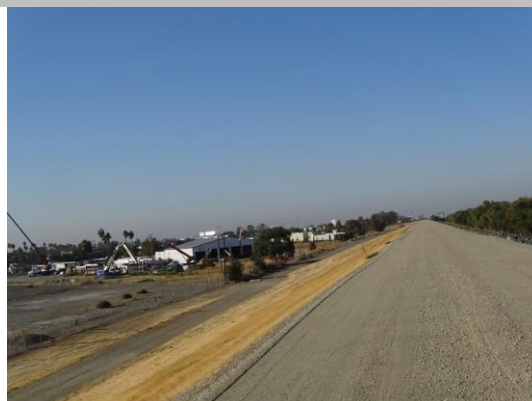
Photo 1 of 1 : FA\_2018\_RD0900\_231\_41\_20181022\_00050.jpg

View of waterside vegetation. Fall 2018

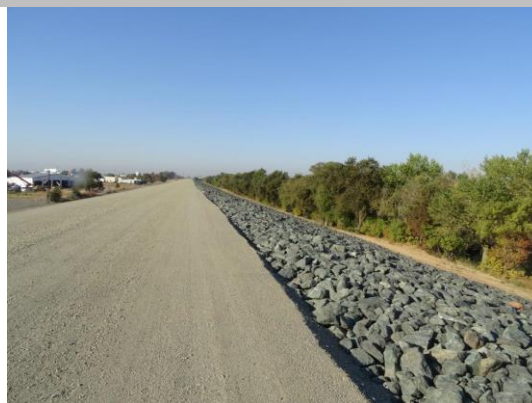
Photo 1 of 1 : FA\_2018\_RD0900\_231\_42\_20181022\_00051.jpg

View of landside vegetation. Fall 2018

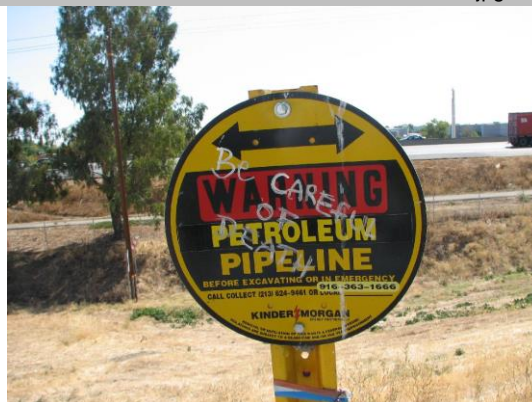
Photo 2 of 3 : UCIP\_FA\_2018\_41825\_72724.jpg

Marker of petroleum pipeline unable to confirm permit--there are 3 gas line in desk study records for gas line but none for Kinder Morgan.

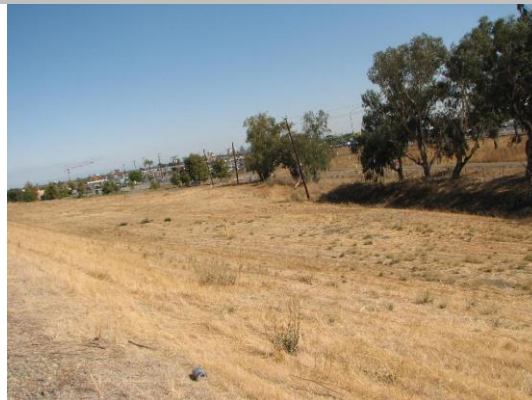
Photo 3 of 3 : UCIP\_FA\_2018\_41825\_72723.jpg

Additional marker visible on landward side--unable to confirm if line is tied to other marker near levee shoulder.

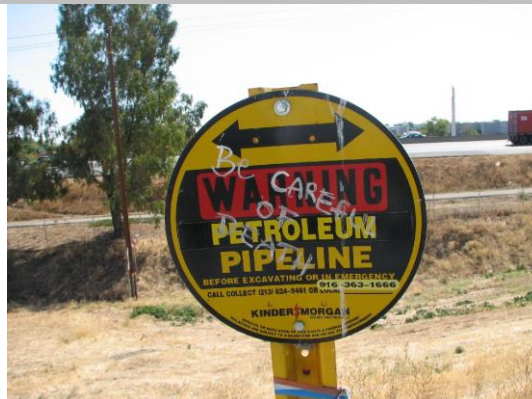
Photo 2 of 3 : UCIP\_FA\_2018\_41826\_72721.jpg

Marker of petroleum pipeline unable to confirm permit--there are 3 gas line in desk study records for gas line but none for Kinder Morgan.

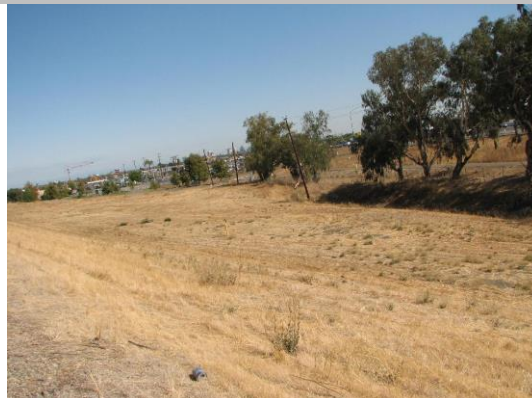
Photo 3 of 3 : UCIP\_FA\_2018\_41826\_72720.jpg

View of additional marker visible on landward side.

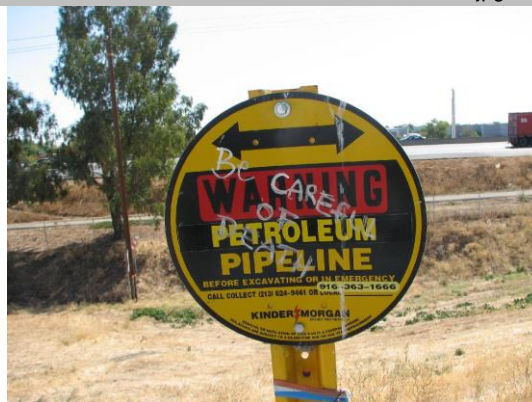
Photo 2 of 3 : UCIP\_FA\_2018\_41824\_72727.jpg

Marker of petroleum pipeline unable to confirm permit--there are 3 gas line in desk study records for gas line but none for Kinder Morgan.

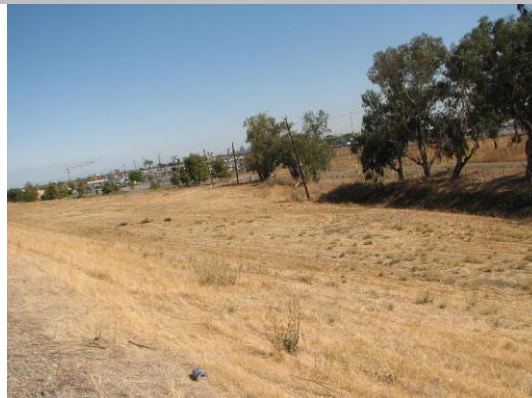
Photo 3 of 3 : UCIP\_FA\_2018\_41824\_72726.jpg

View of additional marker visible on landward side.

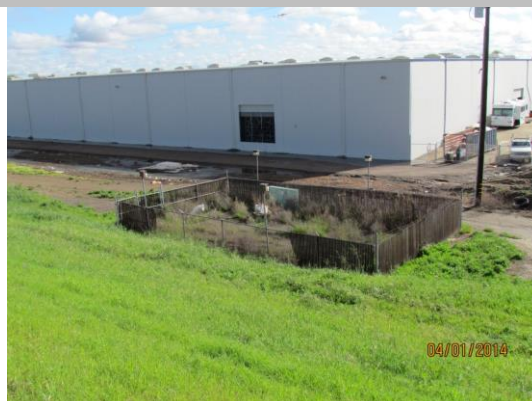
Photo 1 of 1 : FA\_2018\_RD0900\_231\_5\_20180910\_00001.jpg

View of the water well on the landside toe of the levee looking upstream.

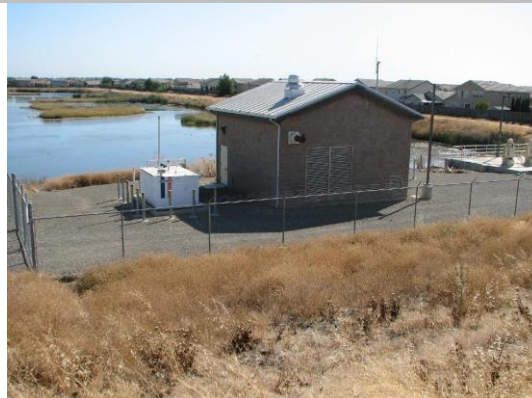
Photo 3 of 3 : UCIP\_FA\_2018\_37770\_68624.jpg

House structure located on waterward side.

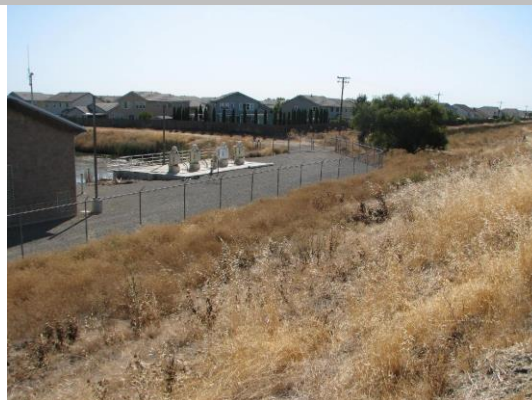
Photo 2 of 3 : UCIP\_FA\_2018\_37766\_68619.jpg

Concrete pad with pumps located on landward side.

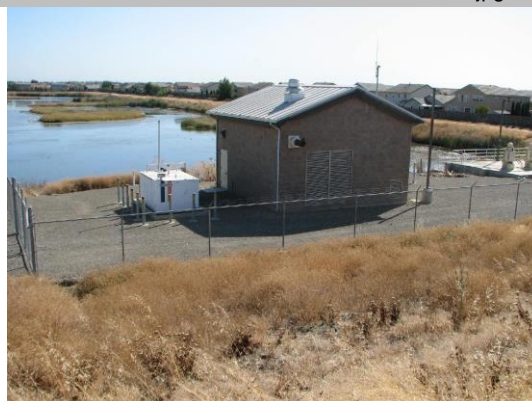
House structure located on landward side.

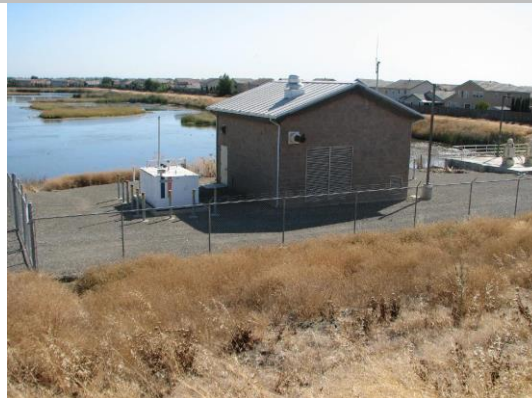
Photo 3 of 3 : UCIP\_FA\_2018\_37778\_68648.jpg

House structure located on landward side.

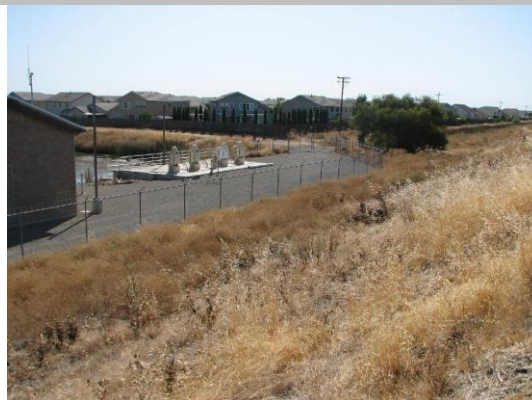
Photo 2 of 3 : UCIP\_FA\_2018\_37780\_68661.jpg

Pump station located on landward side.

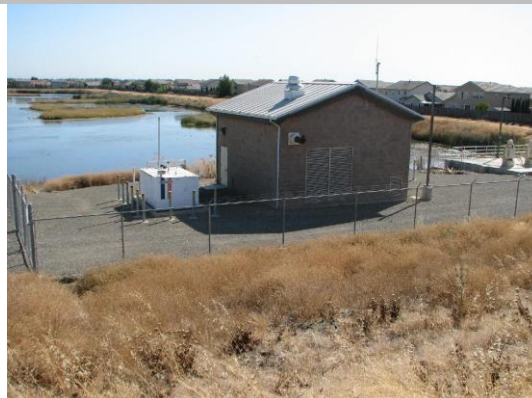
Photo 3 of 3 : UCIP\_FA\_2018\_37780\_68660.jpg

Structure located next to pump station visible on landward side.

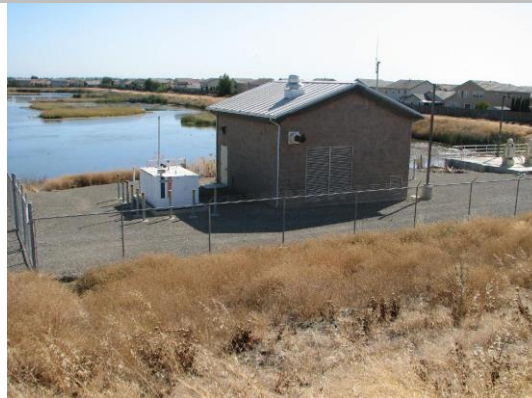
Photo 3 of 3 : UCIP\_FA\_2018\_37781\_68674.jpg

Pump station located on landward side, photo 2 of 2.

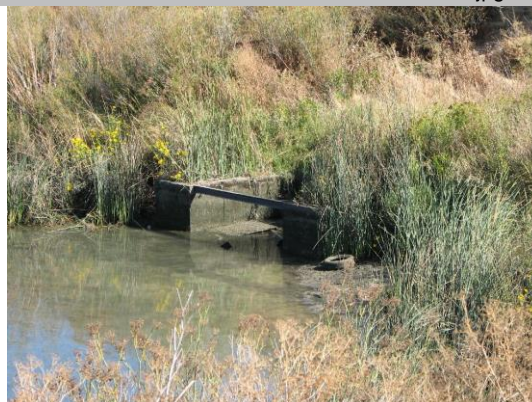
Photo 2 of 3 : UCIP\_FA\_2018\_37785\_68692.jpg

Concrete outlet visible on waterward side.

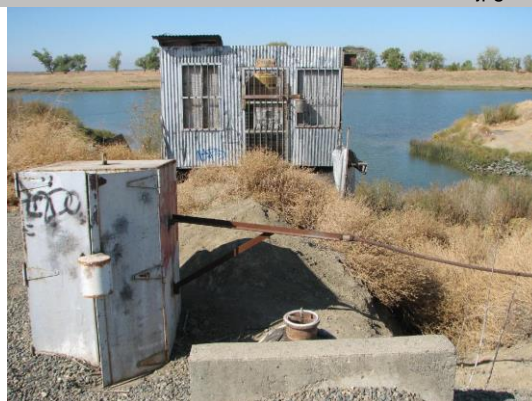
Photo 3 of 3 : UCIP\_FA\_2018\_37785\_68691.jpg

View of pump house visible on waterward side.

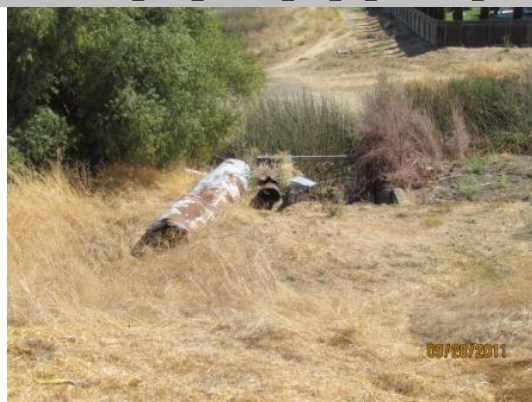
Photo 1 of 1 : FA\_2018\_RD0900\_231\_15\_20180910\_00002.jpg

Abandoned pipes and debris was found on the landside of the levee looking upstream.

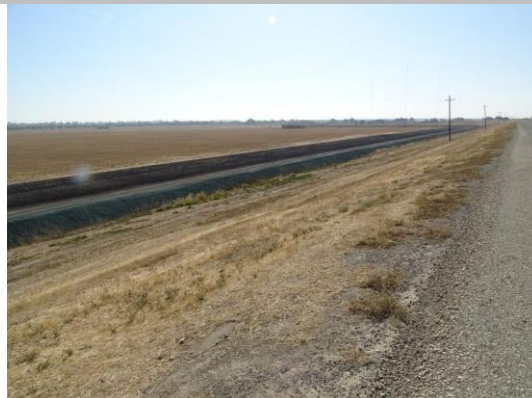
Photo 1 of 8 : FA\_2018\_RD0900\_231\_40\_20181022\_00052.jpg

View of repaired slope instability site. Fall 2018

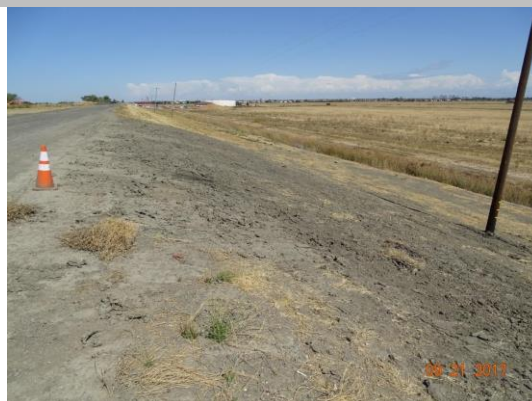
Photo 5 of 8 : FA\_2018\_RD0900\_231\_40\_20180910\_00006.jpg

View of the repaired slope instability site on the landside slope of the levee looking upstream on levee mile 5.26 (38.511915, -121.582167).  
Fall 2017

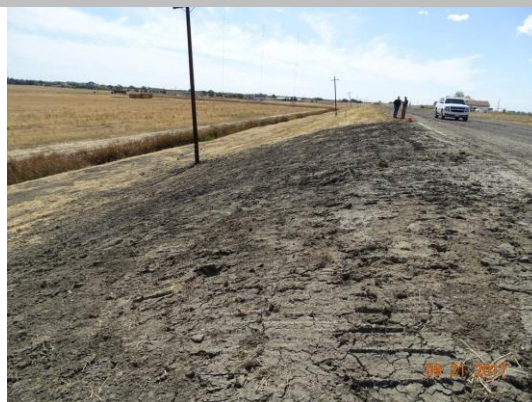
Photo 6 of 8 : FA\_2018\_RD0900\_231\_40\_20180910\_00007.jpg

View of the repaired slope instability site on the landside slope of the levee looking downstream on levee mile 5.26 (38.511915, -121.582167).  
Fall 2017

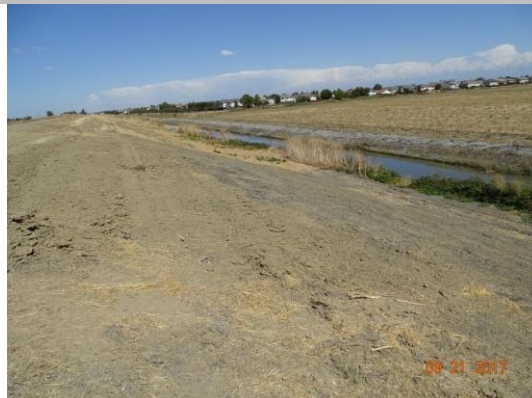
Photo 7 of 8 : FA\_2018\_RD0900\_231\_40\_20180910\_00008.jpg

View of a repaired slope instability site on the landside of the levee looking upstream on levee mile 4.63 (38.52111, -121.582148). Fall 2017

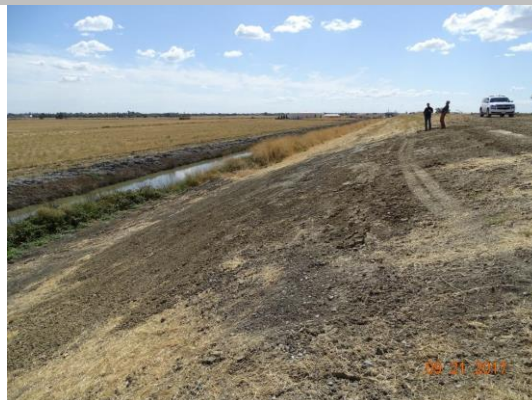
Photo 8 of 8 : FA\_2018\_RD0900\_231\_40\_20180910\_00009.jpg

View of a repaired slope instability site on the landside of the levee looking downstream on levee mile 4.63 (38.52111, -121.582148). Fall 2017

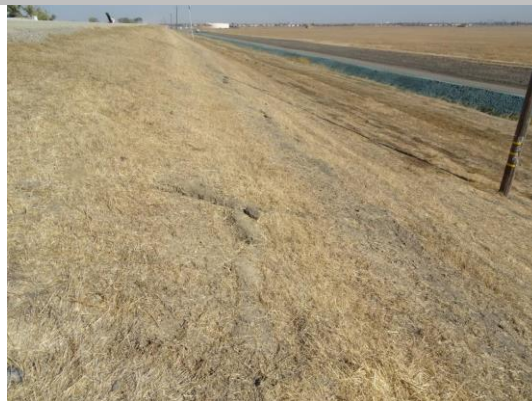
Photo 1 of 1 : FA\_2018\_RD0900\_231\_27\_20181022\_00053.jpg

View of desiccation cracks on levee. Fall 2018
